Bolt M36x140- 10.9 magnetically crack tested

Artikel-Nr: 7988047

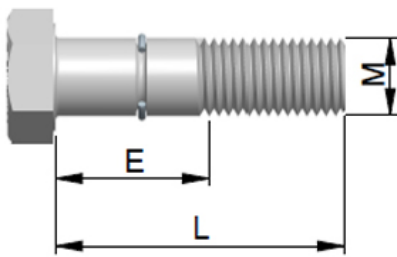
100% crack detected hexagon- head and -socket bolt for the assembly of the VLBG-PLUS.

When used with the VLBG-PLUS the resulting free thread reach $H =$ mm. For assembly at VLBG-PLUS a snap ring is required.

| B | 55 mm | 2-5/32" |
| C | 22 mm | 7/8" |
| E | 75 mm | 2-15/16" |
| L | 140 mm | 5-1/2" |
| M | M36 mm | M36 |
